WORLD WAR II GERMAN  
FIRE DOCUMENT TRANSLATIONS

## **WORLD WAR II GERMAN FIRE DOCUMENT TRANSLATIONS**

REPORT OF THE REGIMENTAL COMMANDER OF THE FIRE-PROTECTION POLICE REGIMENT "SAXONY" ABOUT THE COURSE AND RESULTS OF THE MASSIVE AERIAL ATTACKS ON ROTTERDAM ON MAY 14, 1940, AND THE EXPERIENCES DRAWN THEREFROM (by Hans Rumpf) . . . . .	A-1
The Air Defense Fire Service . . . . .	A-1
The German Action to Occupy Rotterdam and the Aerial Attack of May 14 . . . . .	A-2
The Consequences . . . . .	A-3
The Organization of the Rotterdam Fire Department . . . . .	A-12
Efforts of the Voluntary Fire Department of Rotterdam After the Great Aerial Attack of May 14 . . . . .	A-21
Losses of the Rotterdam Fire Department . . . . .	A-24
Eyewitness Accounts . . . . .	A-25
Comments on the Foregoing Eyewitness Accounts . . . . .	A-40
The Renewed Superiority of Effects of Fire . . . . .	A-44
Additional Observations . . . . .	A-55
Appendix (to Rumpf's Report) . . . . .	A-71

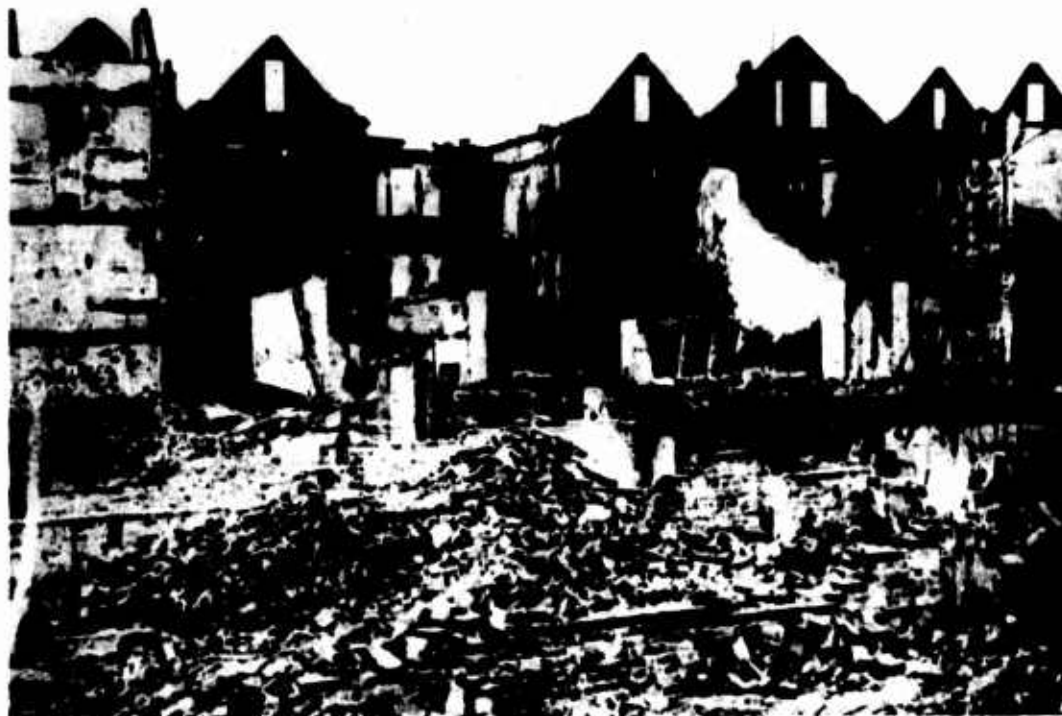
Pictures 59,60 MELTED AND TWISTED BEAMS

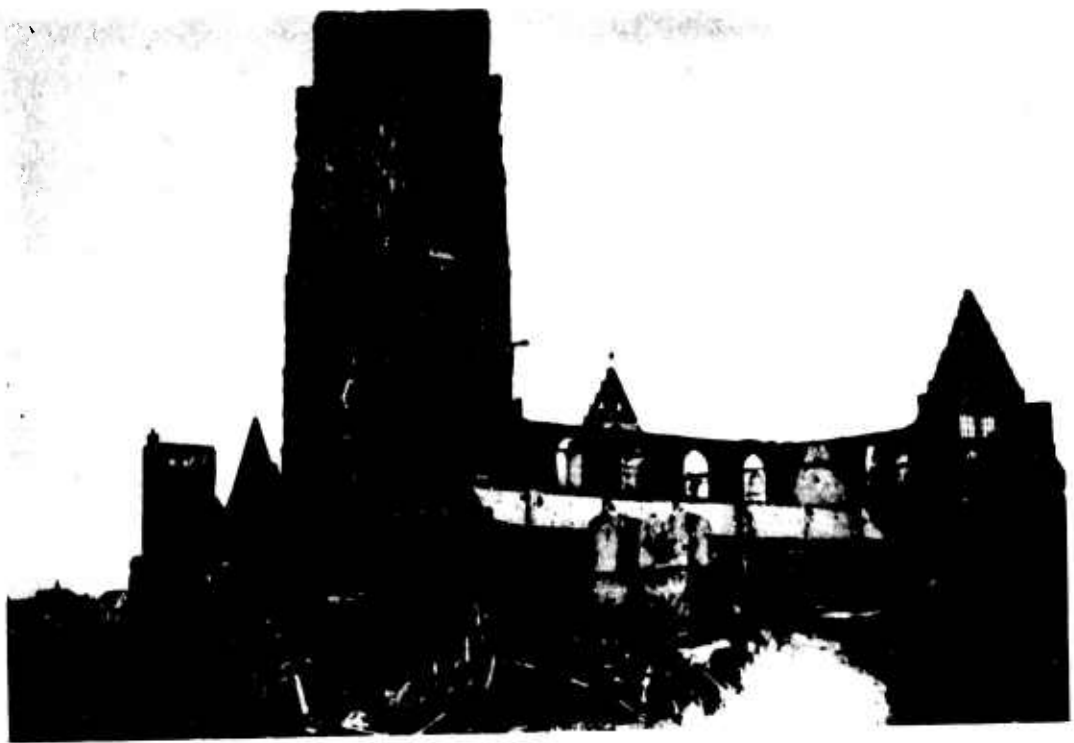
**Picture 61 BRICK DAMAGE FROM EXTREME HEAT**

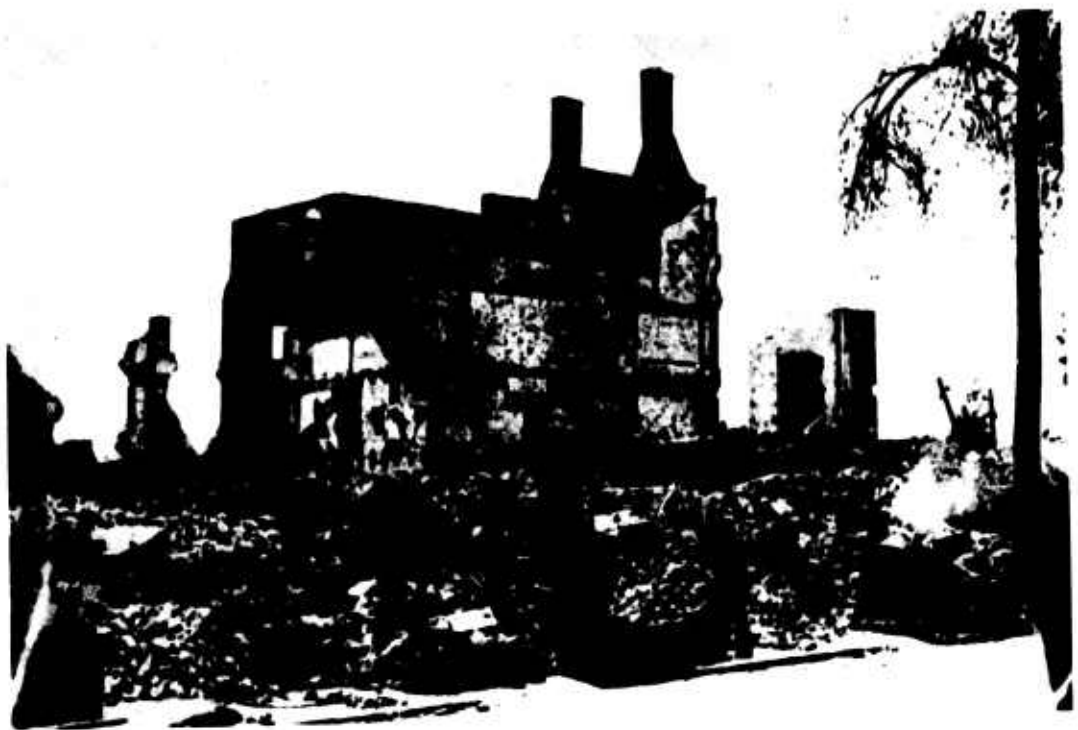
**Picture 62 STEEL VAULT IN CENTER OF DESTROYED BUILDING**

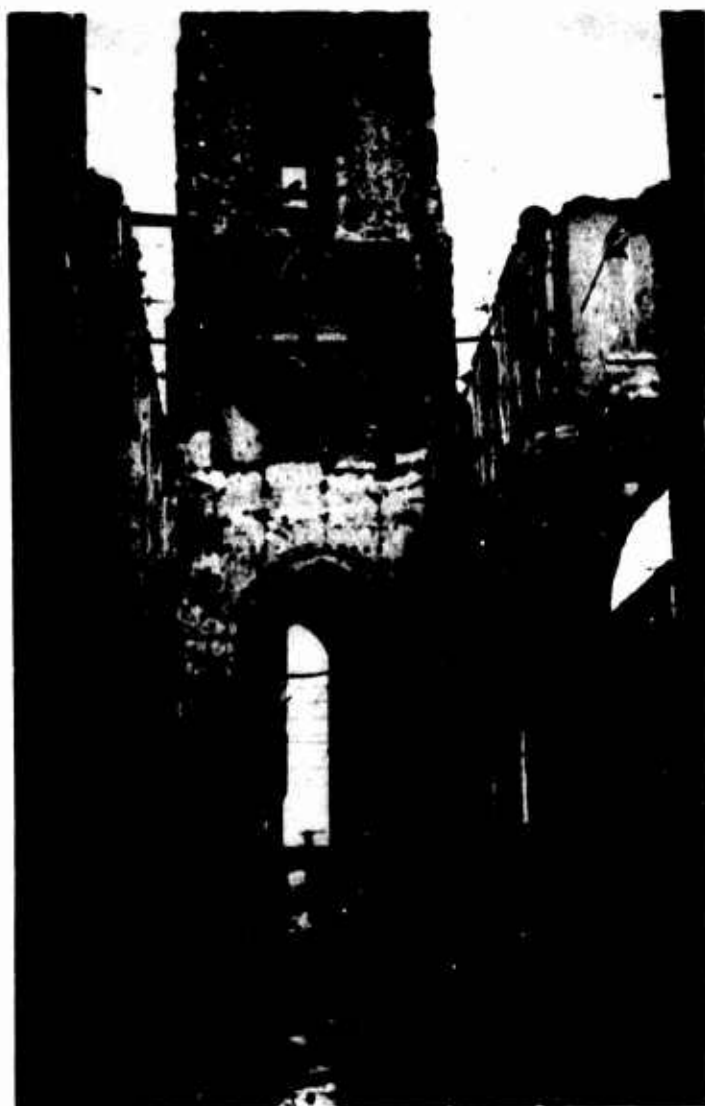
**Picture 67 ST. LAURENS CHURCH SHOWING EVIDENCE OF  
FIRE-CAUSED SPLINTERING AND PEELING OF  
SANDSTONE**

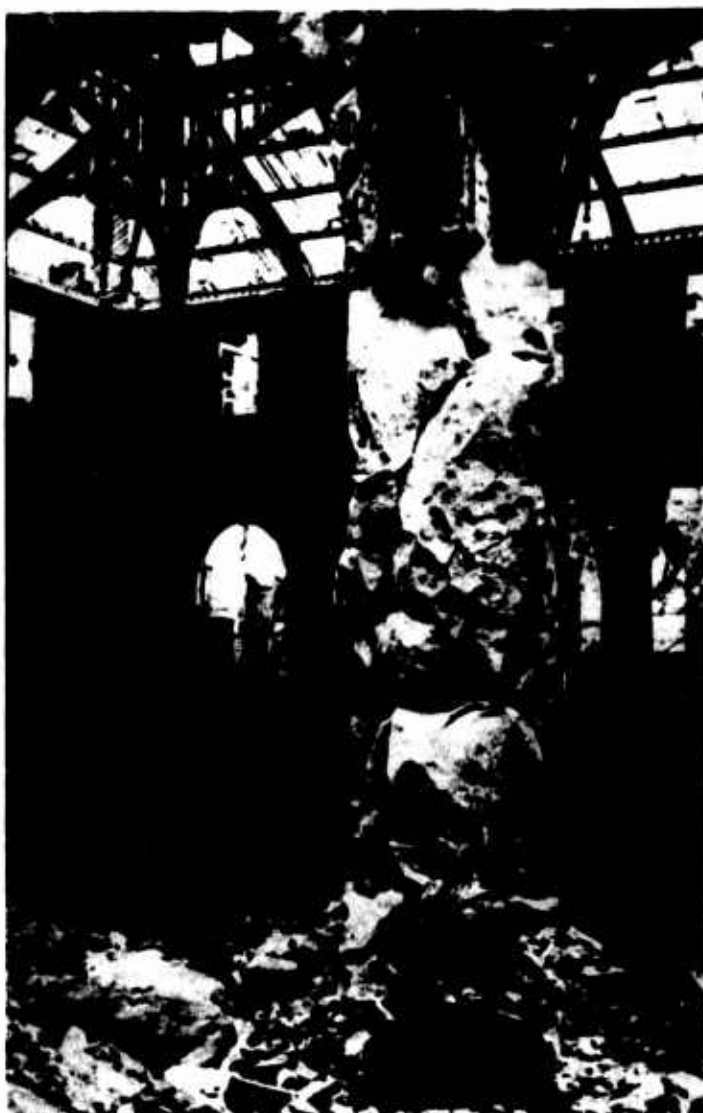
**Picture 68** DAMAGED SANDSTONE COLUMN IN FIRE-GUTTED  
OLD STOCK-EXCHANGE BUILDING

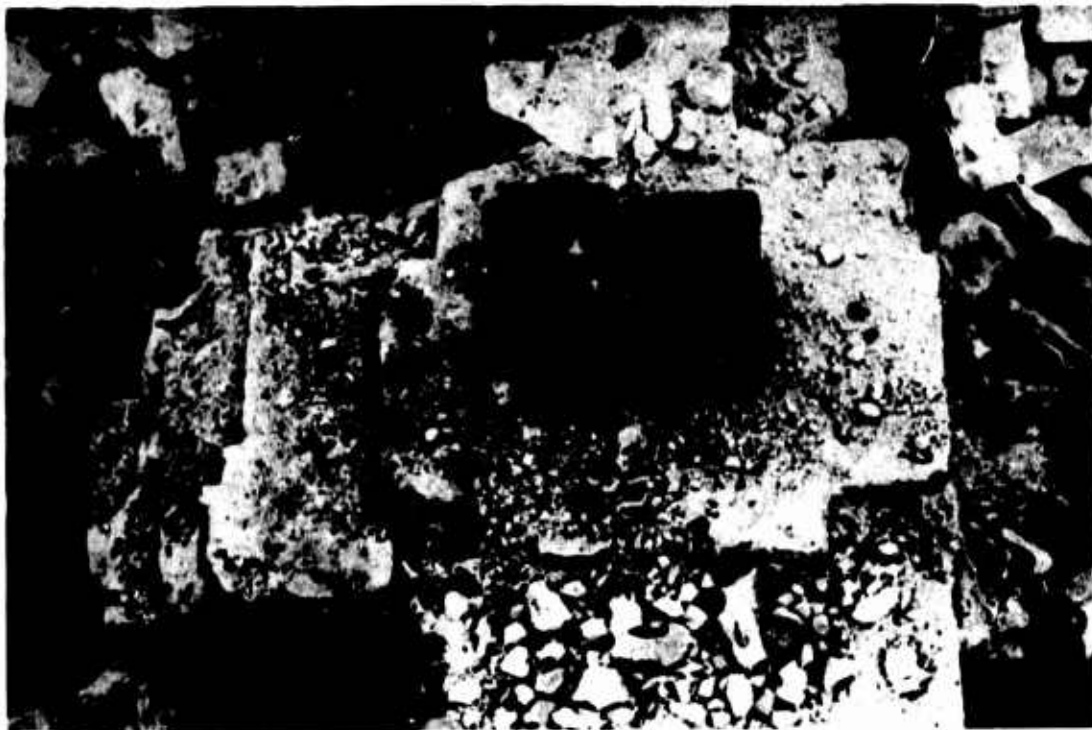
**Picture 70 FIRE-DAMAGED YELLOW AND RED BRICKS**

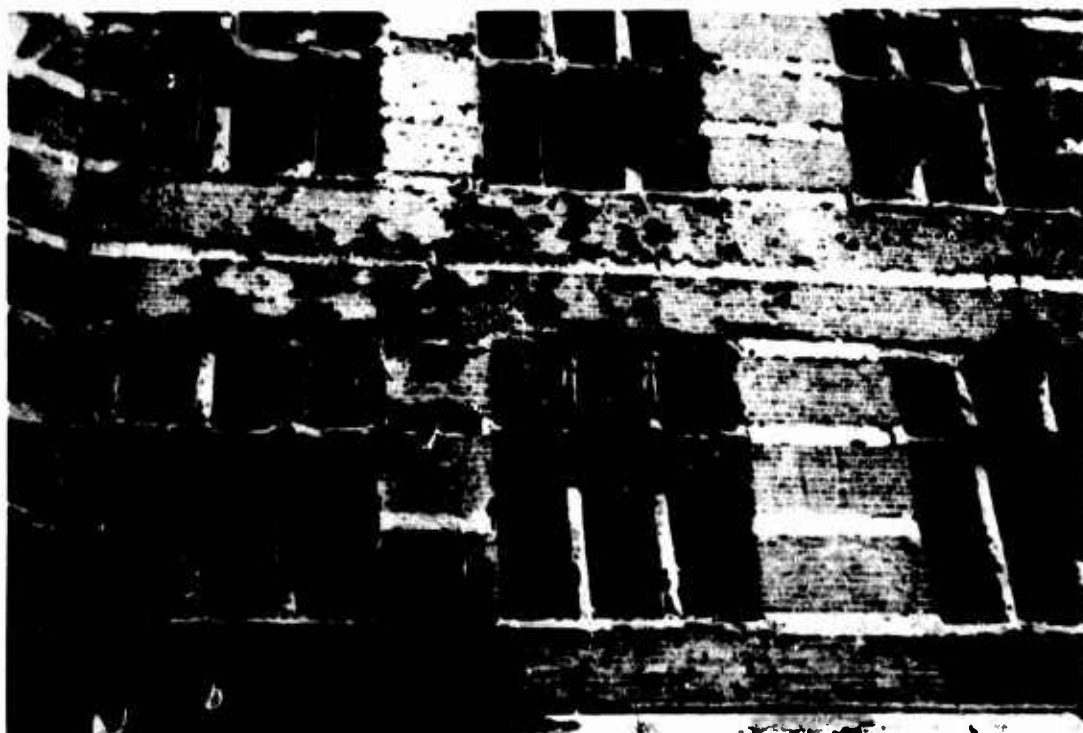
**Picture 71 FIRE-DAMAGED BRICK AND SANDSTONE**

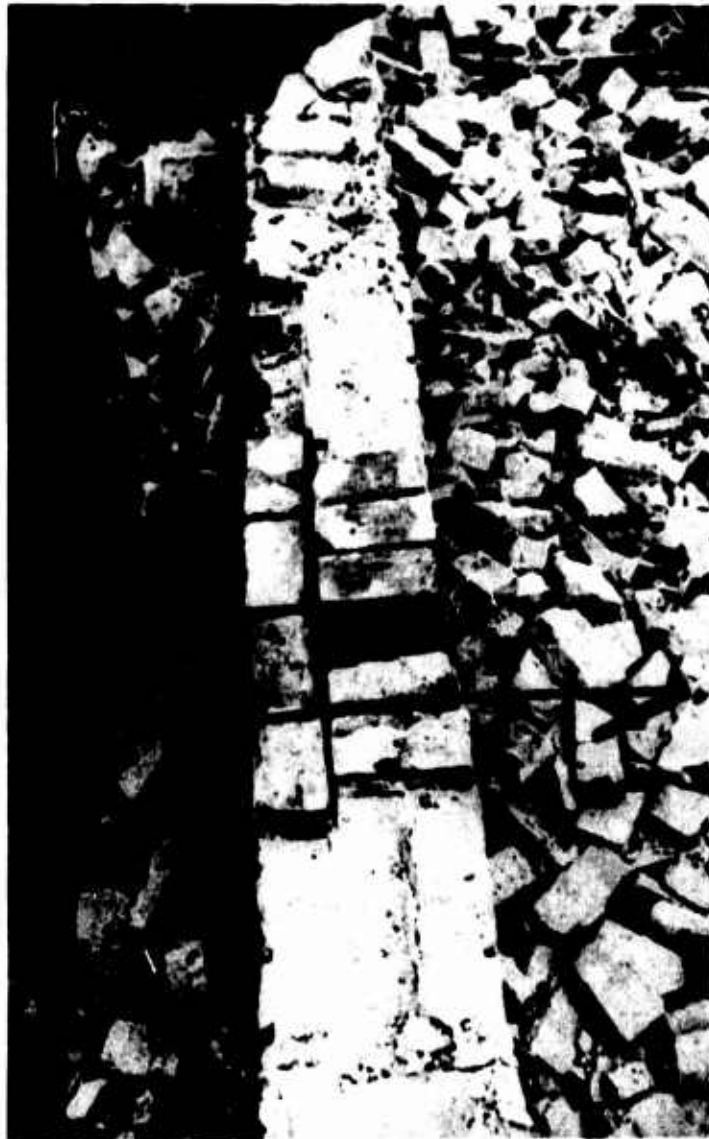
**Picture 73 FIRE-DAMAGED BRICK FIRE WALLS**  
(Note contiguous mortar layer between inner and outer wall)

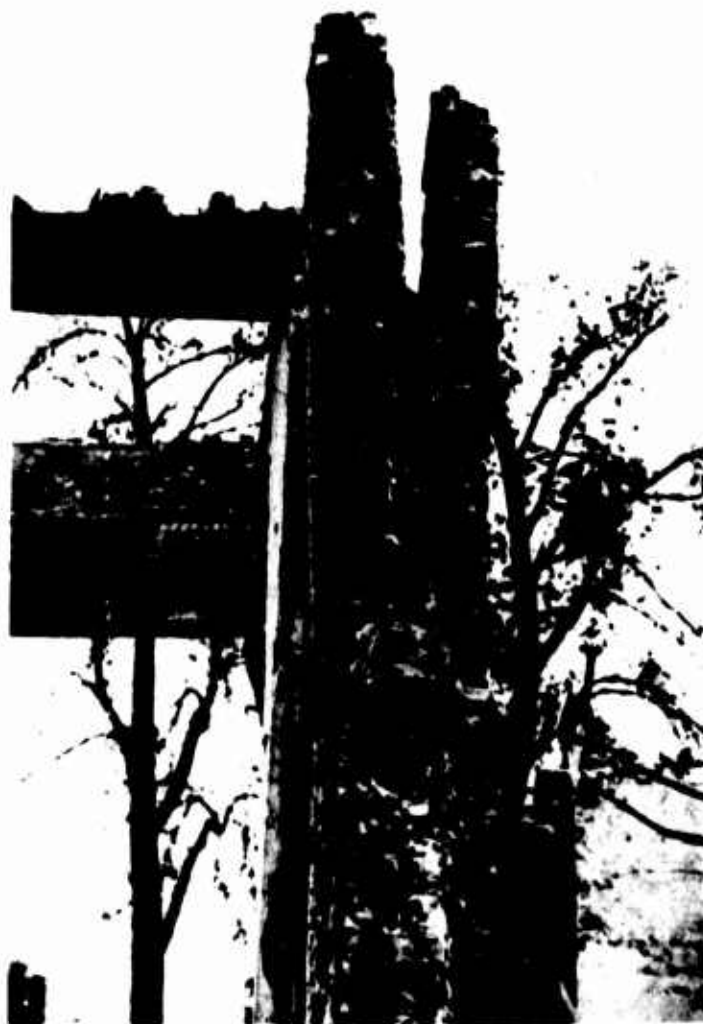
This loose joining permitted the embedded girders, after heating up, to crush the walls they were supporting (Picture 74).

Picture 74 FIRE-DAMAGED BRICK WALLS

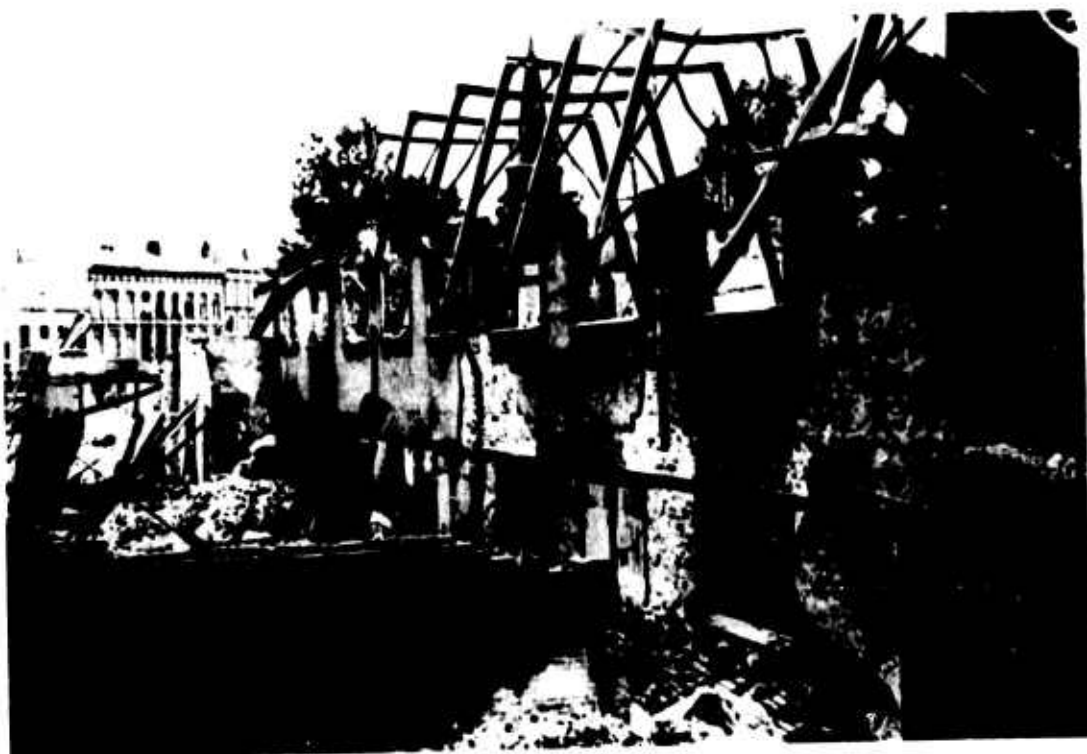
**Picture 76 FIRE-DESTROYED ROOF OF NIGHTCLUB IN COOLSINGEL DISTRICT**

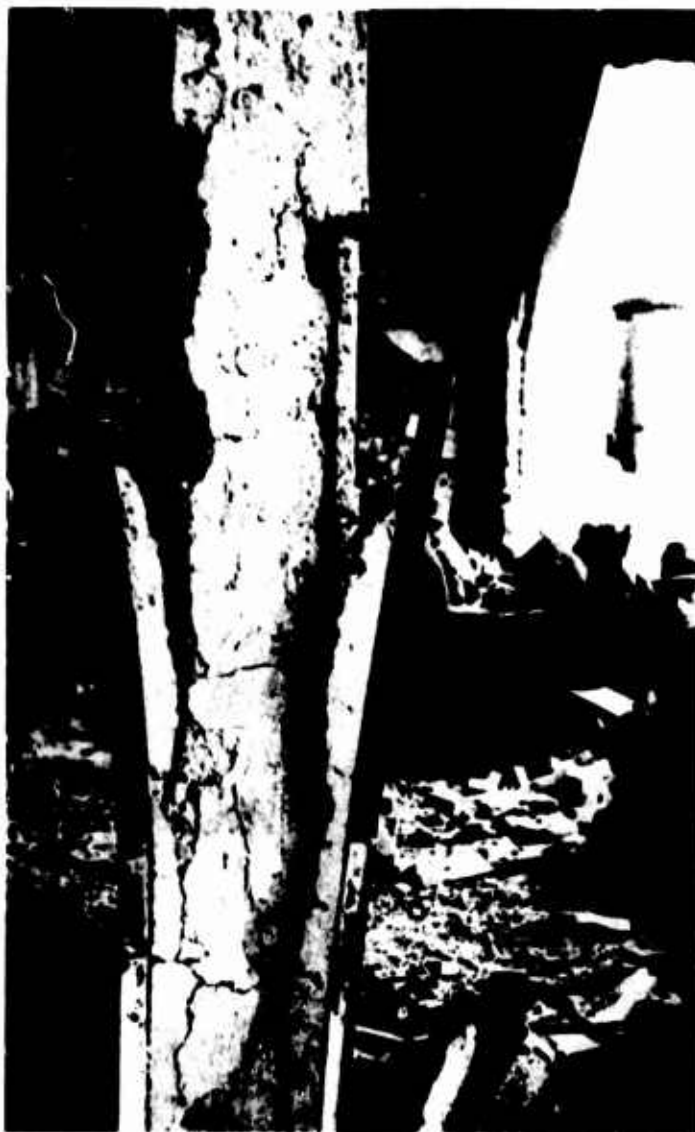
The effect of fire on reinforced concrete buildings is shown in Picture 77. In picture 77, the angle irons are torn out of the supports

**Picture 77 FIRE-DAMAGED CONCRETE PILLAR WITH BENT ANGLE-IRONS**

through the effects of the fire. In other instances, the stone masonry lost firmness to such an extent that the reinforced concrete ceiling collapsed of its own weight.
